TECHNICAL REPORT HL-83-12

# BARKLEY DAM SPILLWAY TAINTER GATE AND EMERGENCY BULKHEADS CUMBERLAND RIVER, KENTUCKY

Hydraulic Model Investigation

August 1983

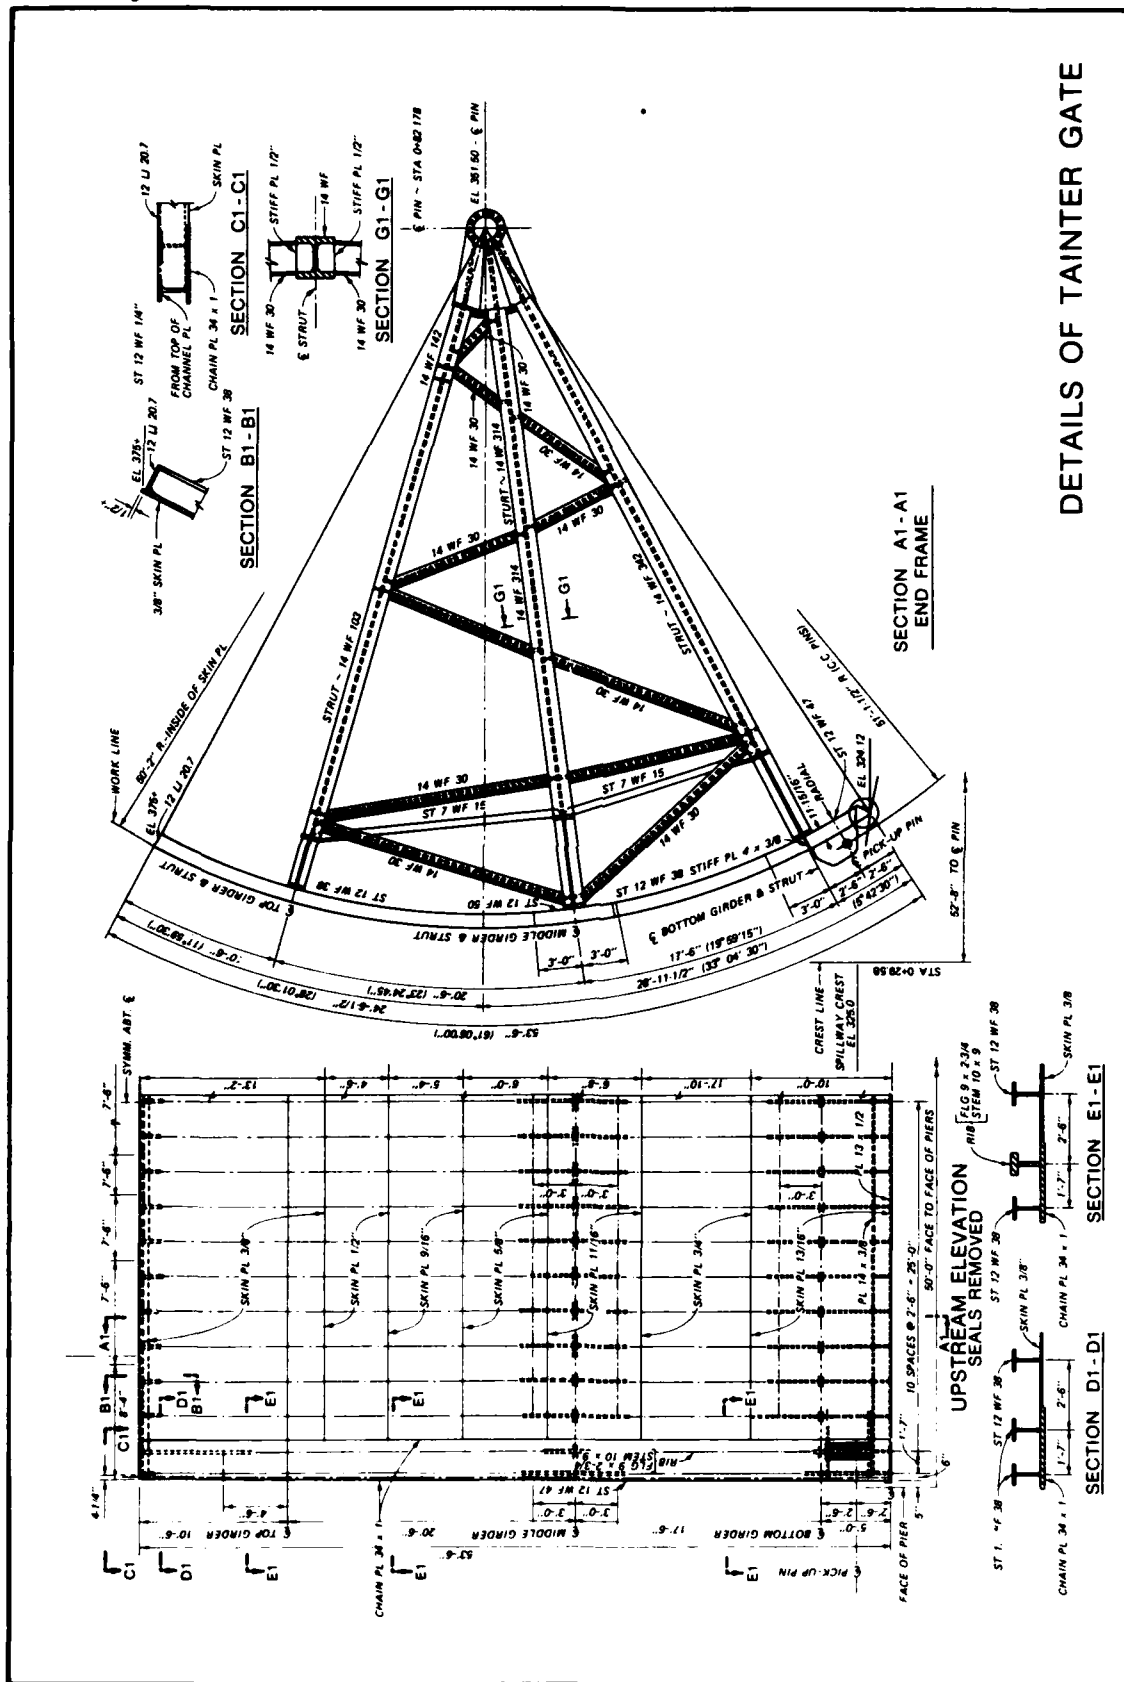
## TAINTER GATE SECTIONS

**HALF SECTION AT TOP GIRDER**

HALF SECTION AT  
MIDDLE & BOTTOM GIRDERS  
AS SHOWN & NOTED

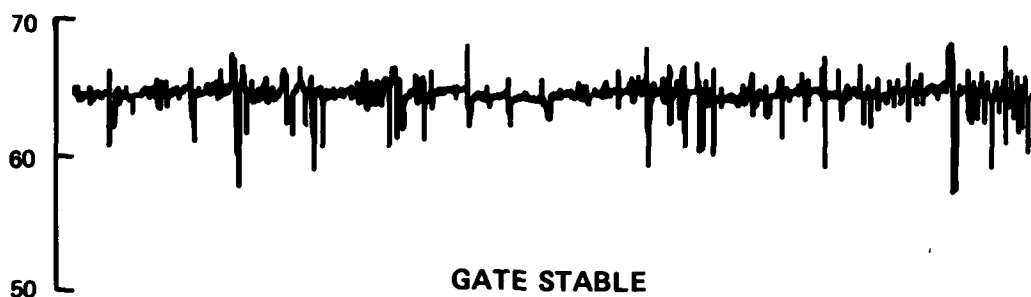
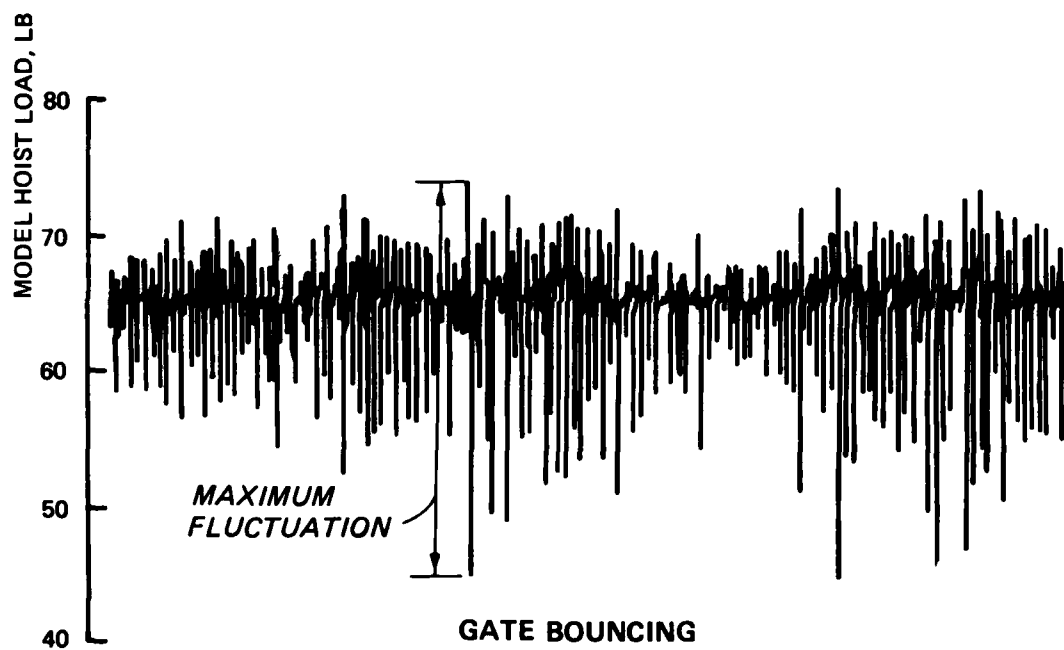
GATE STABLE

POOL EL 358.0  
TAILWATER EL 348.0  
TEST GATE OPENING 20 FT

OSCILLOGRAPH RECORDING  
SPILLWAY TAINTER GATE

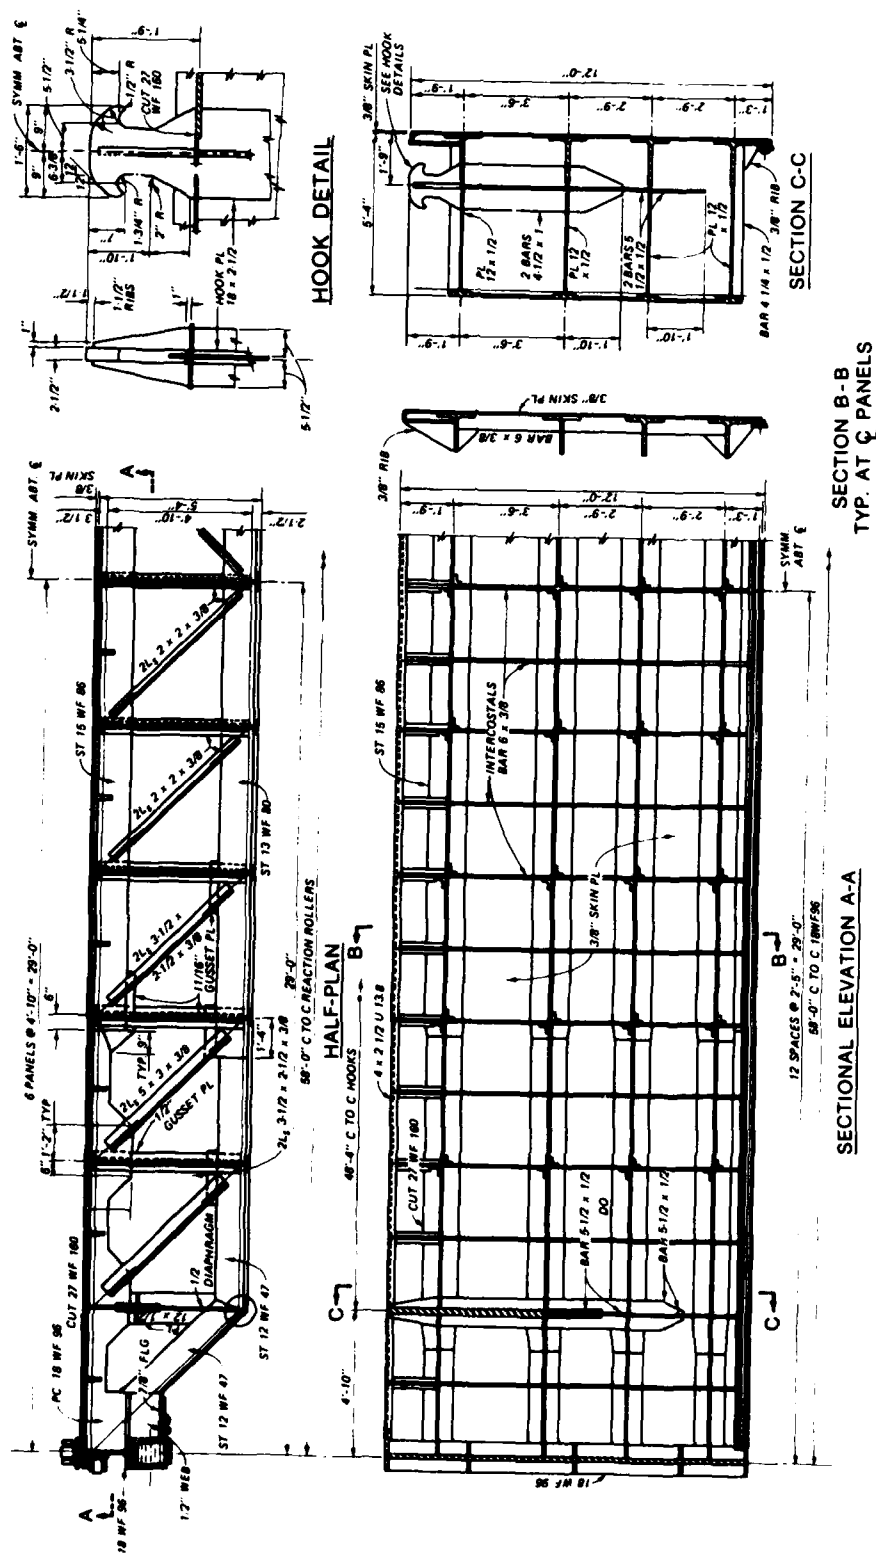
EMERGENCY BULKHEAD  
PLAN, DETAILS, AND SECTION

36. Tests were conducted to determine the hydraulic forces on the lifting frame and emergency bulkheads under flowing conditions in the 1:15-scale model. Details of the lifting frame are shown in Plate 9 and details of the bulkhead are shown in Plates 10 and 11. The first series of tests were conducted with the original design to simulate placement of the first bulkhead unit on the crest for pool elevations of 359.0, 354.0, and 346.0, both with and without tailwater effects. The hydraulic forces were determined by measuring the hoist loads on the suspension cable using a load cell (Figure 7). The loads were recorded on an oscillograph (Plate 12) and were quantitatively transferred to prototype values.

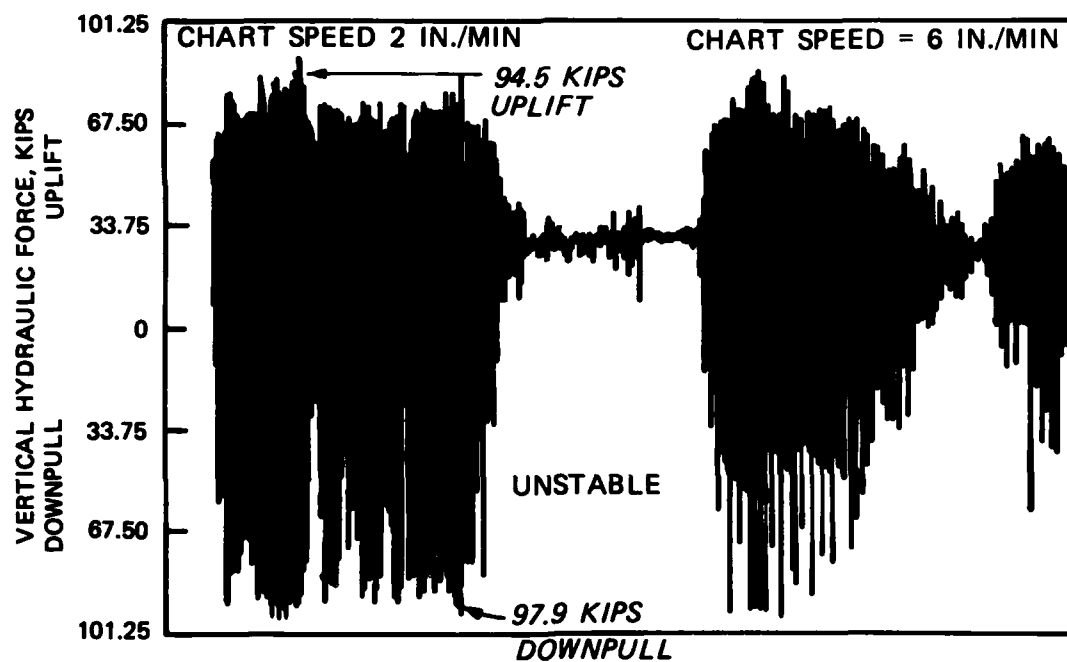
TEST NO. 148  
 POOL EL 359.0  
 TW EL 348.0  
 5-FT GATE OPENING

# HYDRAULIC FORCES LIFTING FRAME AND ONE BULKHEAD UNIT OSCILLOGRAPH RECORDINGS
